INTERNATIONAL CENTRE FOR AUTOMOTIVE TECHNOLOGY

TEST REPORT

C T O B M 5312

- 5.0 OBJECTIVE OF THE TEST:
To validate the Safety Requirements of Traction Batteries as per AIS: 048 amended up to date
- 6.0 TEST RESULTS:
Please refer the Test requirements and Results in Annexure-I of this report.
- 7.0 CONCLUSION:
The battery specified in Sr. No. 4.0 of this test report met all the test requirements when tested as per AIS: 048 amended up to date.

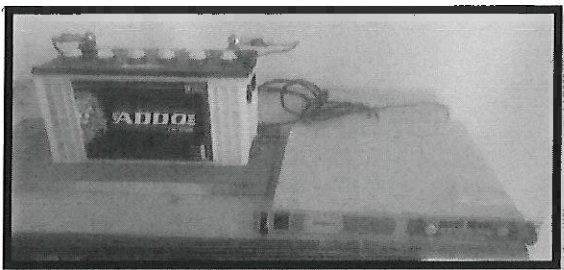
2.1.2	Over Charge test (Test ID:ICAT/ CNG-LPG/53398/02)

<p> Battery Condition: Fully charged (100% SOC), contained at ambient temperature at $27 \pm 5^\circ\text{C}$. Duration: 10 hours The battery is to be overcharged at a constant charging current of 0.1 (C_{10}). </p> <p> Acceptance Criteria: At the end of the test, there shall be no: a) Physical damage to the casing or other mechanical parts. b) Melting of components. c) Fire or explosion. </p>	<p> Battery was charged with 8.33 A for 10 hours. </p> <p> No physical damage, melting or explosion observed. </p> <p> Satisfactory. </p>
-------	---	--	--
